Manhole Inspection Summary

Manhole # S31SS_046MH

Location Address: **2845 HUNTINGDON AVE**

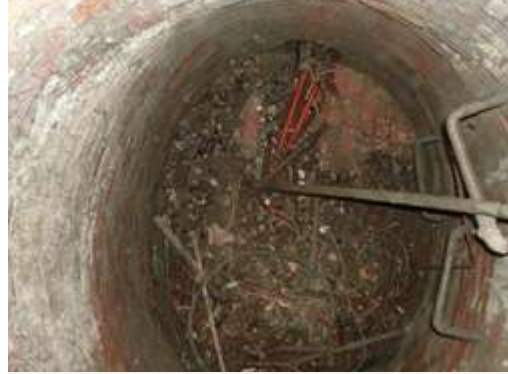
Top View

Channel debris.

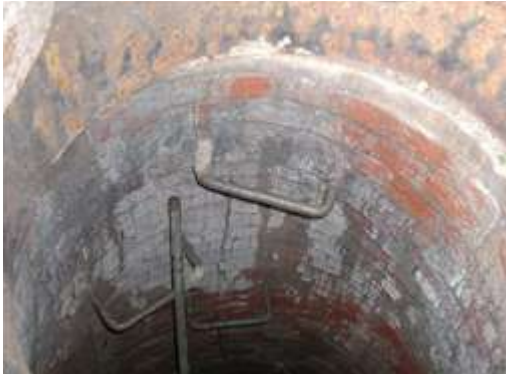
Defect

Adjustment deterioration and infiltration.
Corbel and Barrel infiltration - other side.

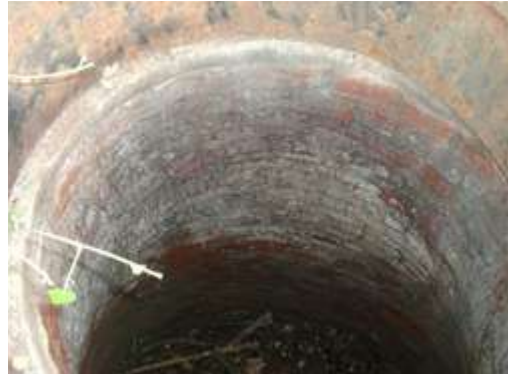
Defect

Frame leaks. Adjustment deterioration
and infiltration. Barrel infiltration.

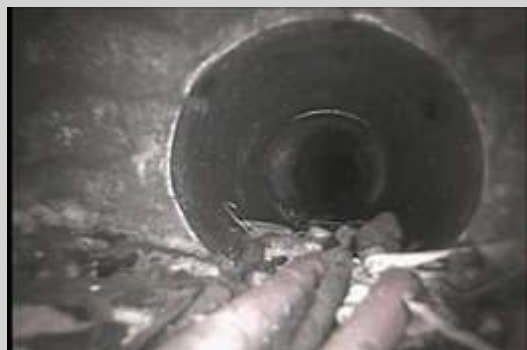
Pipe Out @ 12 O'Clock

Rod and Bar (Angled)

Deposits: ☐ None ☐ Mud ☐ Sludge ☒ **Debris** ☐ Grease

Deposits Extent: **Light**
